Service: **RESERVE STUDY**

Project No.: 21-0136-NC

RESERVE STUDY UPDATE

CAROLINA FOREST COMMUNITY SERVICE ASSOCIATION (CSA) 912-914 SAVANNAH DRIVE JACKSONVILLE, NORTH CAROLINA 28546

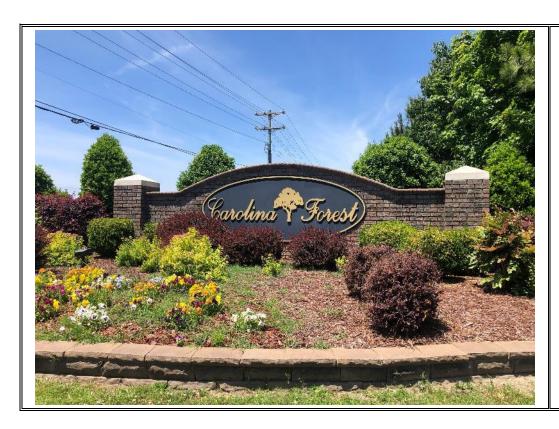
1

Entrance signage.

Three large monument entrance signs are located along Carolina Forest Drive in the community at the intersections of Western Blvd, Stagecoach Drive and Ramsey Road. The composite signs are mounted on a brick monument structure. Two of the signs include an EIFS type stucco trim around the composite sign. The brick monument structures appeared to be in good condition and will not likely require significant repair over the term of the study. The composite sign inlays appeared to be in good condition. Over time the composite sign inlay will likely begin to fade in color and deteriorate. We have allocated funds to repair and paint the monument entrance signs on a 10-year cycle beginning in 2030.

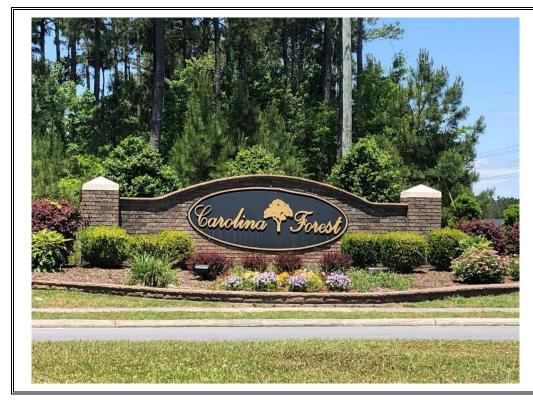
Additional entrance signage.

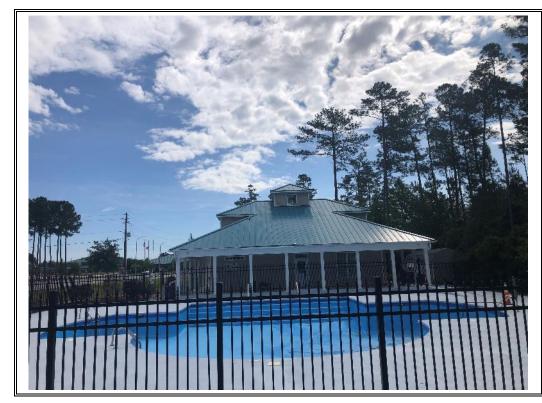
Overview of clubhouse building and pool.

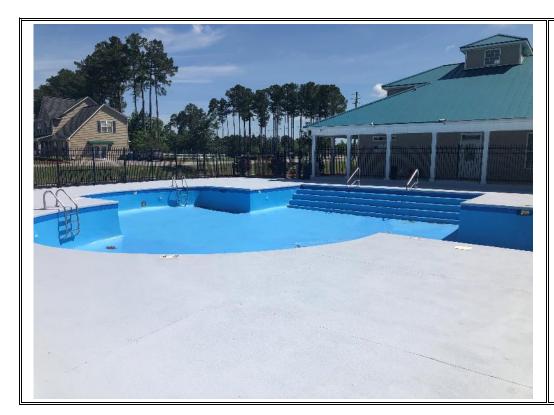
5

Condition of pool deck and empty pool at time of inspection.

The pool deck was comprised of concrete and includes a textured coating. Per information provided, the deck was recently repaired. Limited cracking due to differential settlement in the concrete deck and

deterioration in the textured pool coating will likely require the coating to be refinished on a 10 to 20 year cycle. We have allocated funds in year 12 to repair and refinish the textured coating on the pool deck.

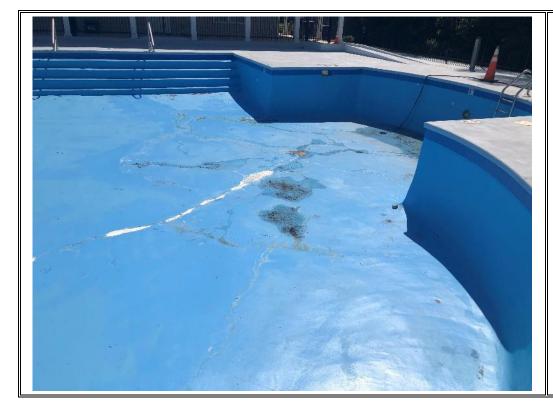
Close-up condition of deteriorated pool surface scheduled for repair.

The swimming pool was constructed in 2012 and the surface appeared to be in poor condition. The pool was drained and not in use at the time of our inspection. Per information provided, repairs were scheduled to repair the pool surface. The pool surface will typically require re-plastering and tile/coping repair on a 12-year cycle. We have allocated funds to repair and re-plaster the pool surface beginning in 2034.

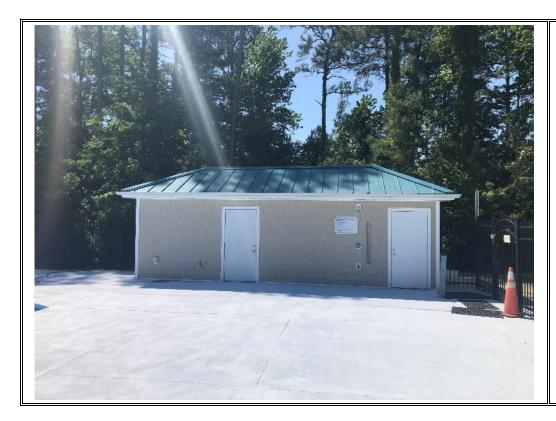
7

Pool pump house.

Due to the environment around the pool, the metal pool pump and chemical room doors will likely corrode and require replacement on an approximately 15-year cycle. We have allocated funds to replace the doors beginning in 2031.

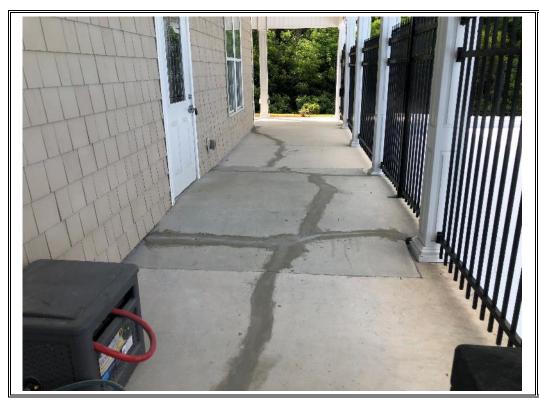
Recently sealed concrete flatwork around clubhouse.

Concrete sidewalks are located around the clubhouse building, roadways and the parking lot. It is likely that due to differential settlement and cracking, sections of the concrete flatwork will require repair. Recent

crack sealing was reported around the clubhouse and pool deck. We have allocated funds for periodic replacement of concrete surfaces as required and have assumed that 2% of the surfaces will require replacement every 8 years beginning in 2026.

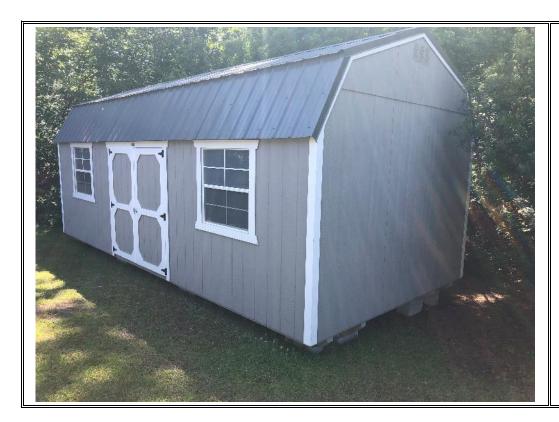
9

Description:Storage building adjacent to clubhouse.

A recently purchased stand alone storage building was observed at the southeast corner of the club house adjacent to the wooded area. We estimate the storage building to have and expected useful life of approximately 20 years. We have allocated funds to paint the siding components along with the scheduled re-painting of the clubhouse and pool building trim components.

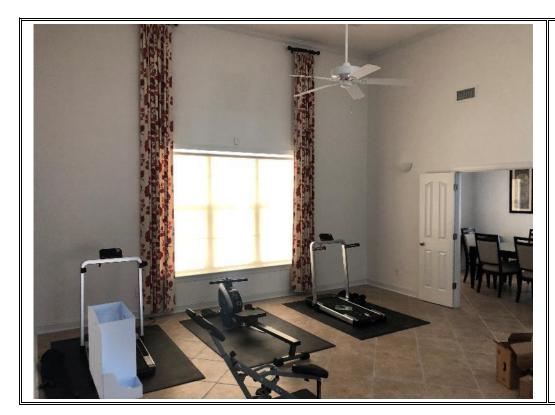
11

Description:Clubhouse interior with exercise equipment.

Additionally, as part of the reported microbial growth discovered within the building, new furnishings were acquired. This included a small section of workout equipment including a treadmill and We have allocated funds on a 15-year cycle to replace the interior furnishings as needed beginning in 2037. This funding would include replacement/upgrade of the audio/visual equipment in the club house.

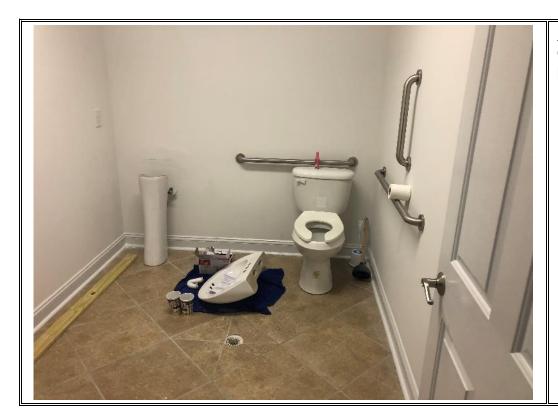
13

Description:Clubhouse
bathroom being
renovated.

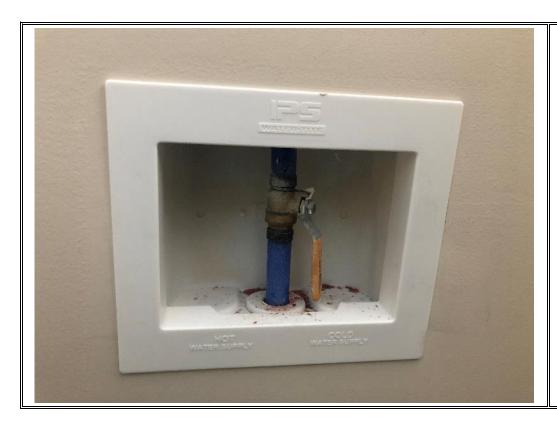
15

<u>Description:</u> Main water supply

Main water supply shut off valve at clubhouse.

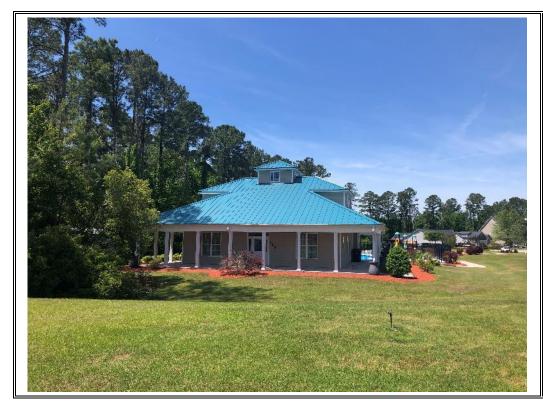
Front elevation of clubhouse.

The club house and pool building exteriors are primarily clad in vinyl siding with aluminum wrapped trim components. Limited trim and column components are comprised of painted PVC or composite material. The exterior doors are painted fiberglass doors. The exterior of the buildings was generally in good condition. We have allocated funds to paint the exterior doors and trim components at the club house and

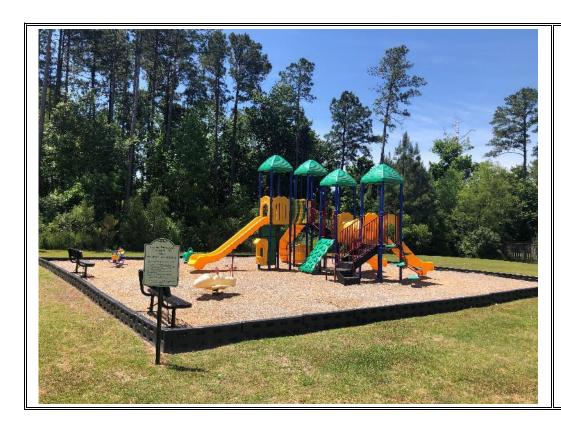
Photo Number **17**

Description: Playground.

A newly installed playground was installed at the west side of the clubhouse. The playground included various slides, climbing apparatuses and equipment. The systems were in good condition. We estimate the equipment to have expected useful lives of approximately 20 years. We have allocated funds to replace the playground equipment beginning in 2041.

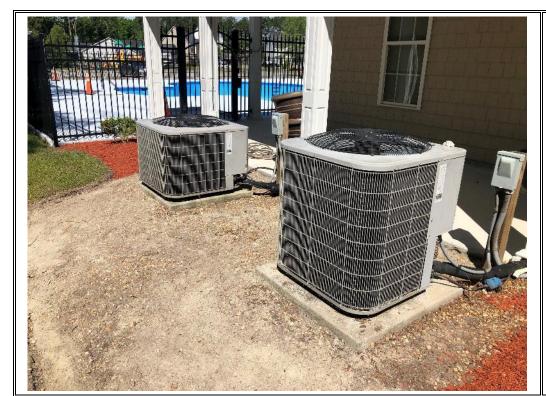
HVAC equipment.

The heating, ventilation and air conditioning (HVAC) equipment serving the clubhouse includes two original Bryant heat pumps located outside and corresponding fan coil units located in the attic space of the clubhouse. The heat pumps include a 5-ton capacity unit and a 4-ton capacity unit. The heat pumps were manufactured in 2011 and have expected useful lives of approximately 15 years. Two small Frigidaire pass through wall mounted heating and air conditioning units are located in the pool building. We have allocated funds for replacing the HVAC equipment on a 15-year cycle beginning in 2026.

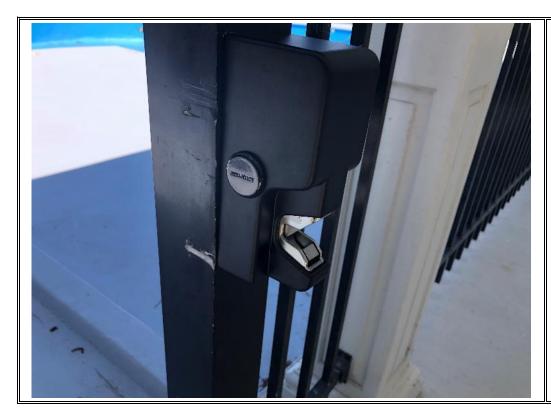
Photo Number 19

Description:Newly installed key fob access control at pool entry gate.

Security cameras have been installed around the club house and pool area. A key fob system provides secured entrance into the pool area and club house. These systems typically require repairs or upgrades on a 10-15 year cycle. Based on information provided both systems were recently upgraded as part of the clubhouse improvements. We have allocated funds to repair/upgrade the security camera and access control systems on a 12-year cycle beginning in 2034.

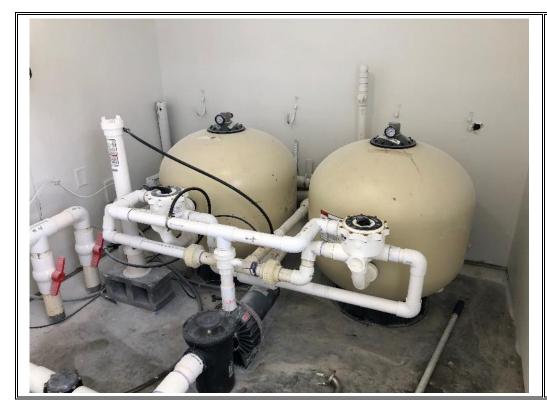
Photo Number **20**

Description:Pool pump and filtration equipment.

The pool pump and filtration equipment includes a 5-horsepower pump and two Triton II sand filters with an automatic chlorinator. The pump was scheduled to be replaced as part of the repairs to the pool. We have allocated funds to repair/replace this equipment on a 10-year cycle beginning in 2037.

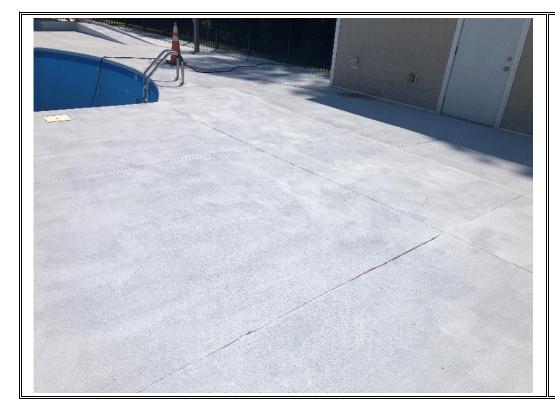
Recently sealed concrete deck at pool.

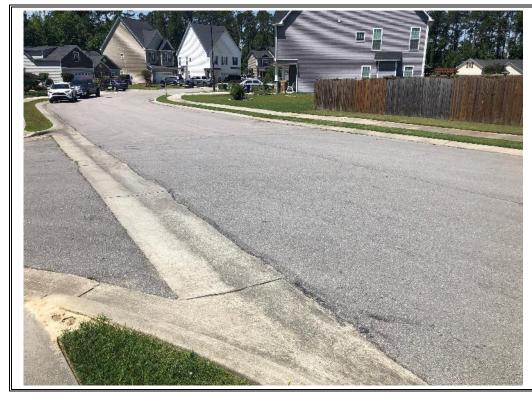
23

Typical community roadways.

The original pavement at other community-maintained roadways appeared to be in good to fair condition. Limited sections of potholes and distressed pavement was observed at limited locations. A failed repaired area of asphalt was observed in front of the driveway at 113 Ironwood Court.

The asphalt roads and parking areas had been scheduled to be resealed on a seven-year schedule thereafter. We have anticipated the need for re-surfacing sections of the asphalt surfaces at the community. This component typically has an estimated useful life of approximately twenty years. We have provided this in a two-phase approach given the amount of reportedly community-maintained roads. Full depth repairs will be required at areas of failed pavement and subgrade. We assumed these expenses for immediate repairs to the asphalt pavement at failed sections would be funded from an annual maintenance budget.

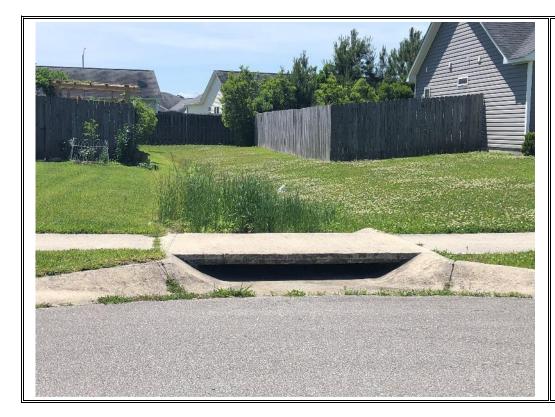
Storm water inlet below concrete sidewalk. Note drainage easement between home sites.

Stormwater on the site drains via surface flow or via landscaped swales toward a stream running through the property. The association is responsible for maintaining portions of the swales located on common property throughout the community. We anticipate the need to improve/maintain drainage in common area drainage systems by re-cutting swales, adding riprap reinforcements and/or repairing erosion. Some of the swales were overgrown with vegetation at the time of our inspection. We have allocated funds for improvements to the overall drainage system on an eight-year cycle beginning in 2025.

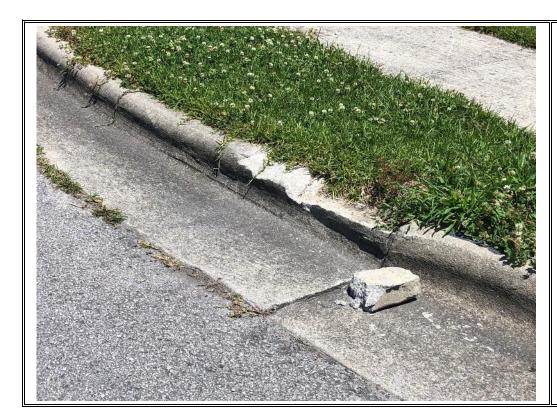
Photo Number **25**

Description:Broken concrete curbing.

Concrete curb and gutter is installed along the perimeter of the parking lot and community drives. Over time, it is likely that cracks and depressions will develop in the concrete curbing. Limited areas of broken concrete curbing was observed along Willoughby Lane. We have allocated funds for periodic replacement of concrete curbing as required and have assumed that 2% of the surfaces will require replacement every 8 years beginning in 2026.

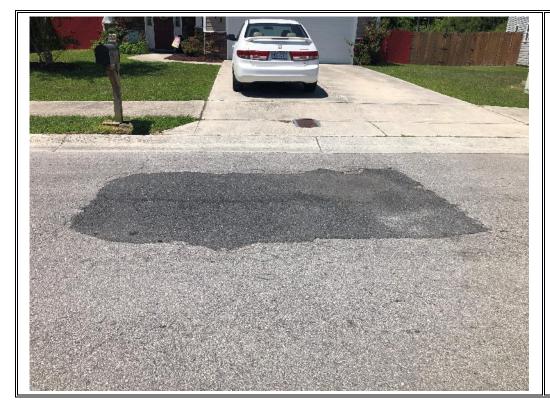
Description: Failed asphalt

pavement patch.

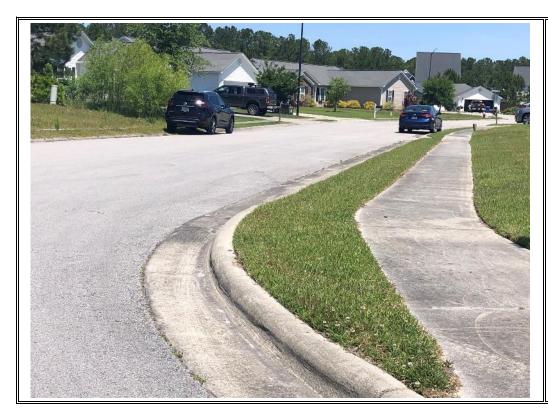
Photo Number **27**

Description:Asphalt roads with concrete curbs and gutters.

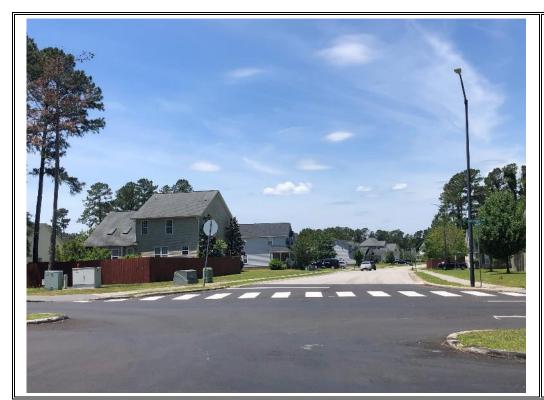
Photo Number **28**

Description:New asphalt at Carolina Forest Blvd.
